**ESTIMATED RESERVE REQUIREMENTS
FOR WESTMINISTER VILLAGE
HOMEOWNERS ASSOCIATION**

Prepared by Huie Reserve Reports
March 17, 2023
© All rights reserved
ralph@huie-reserve-reports.com
770.548.4375

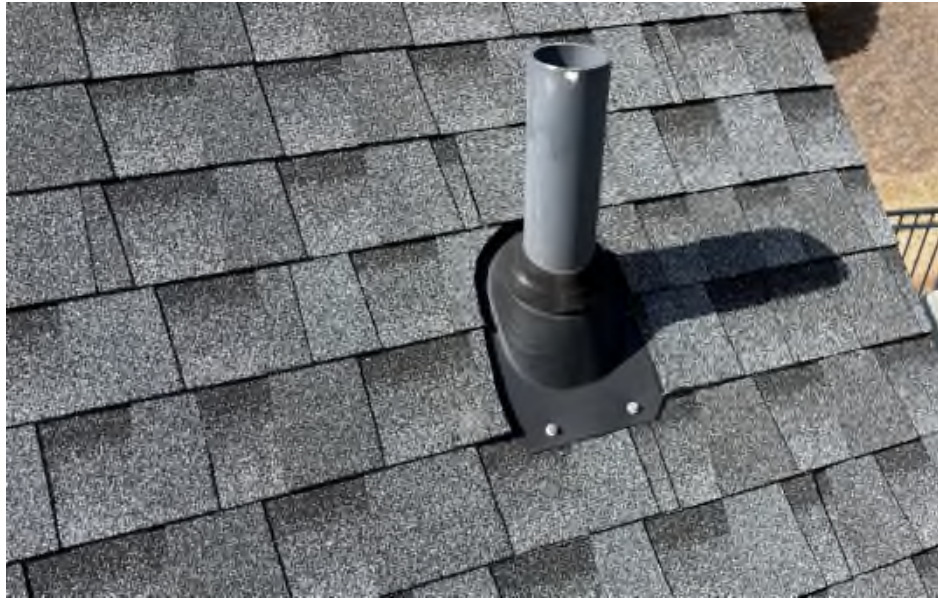
Roof and Gutter Replacement - 35-year normal life. Architectural fiberglass-reinforced shingles with a nominal life of 40 years were installed at the clubhouse.

Shingles seldom have an actual life as long as the nominal life, so a life of 35 years is used in this report. This category covers the replacement of the shingles when they reach the end of their life.

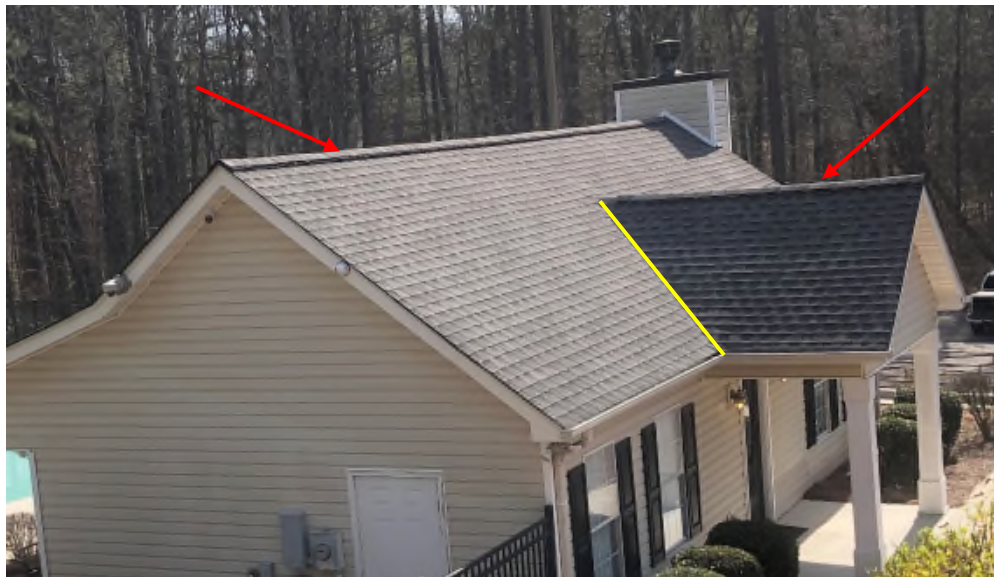
The roof of the clubhouse has shingle over ridge vents (indicated in the previous photo by the red arrows), which are the most effective in allowing warm air to escape the attic. A properly installed ridge vent with proper air intake provided by your perforated vinyl soffit increases energy efficiency and prolongs the life of the roof.

When replacement is necessary, it is recommended that you use the "tear off" method, which means that the old shingles are completely removed before the new shingles are applied. While it is not essential that the old shingles be removed before applying a second roof, it is necessary for the warranty on the new shingles, it does give a longer life to the new roof and also allows defects in the decking and flashing to be clearly seen. It is also recommended that you continue to use a shingle of at least of the quality of the 40-year architectural shingles when the roofing is done. A water-barrier membrane should be placed in the roof valleys (indicated in the previous photo by the yellow line) and in other locations where leaks tend to develop.

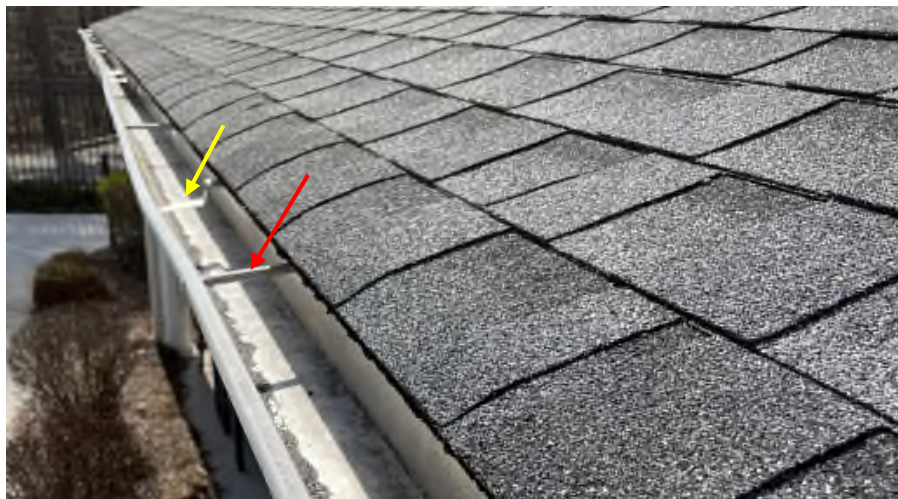
There are approximately 132 LF (linear feet) of 5" prefinished aluminum gutters and 3"x4" downspouts installed at the clubhouse.

Aluminum gutters do not rust as galvanized steel gutters do. The principal cause of failure for aluminum gutters is physical damage from tree limbs and ladders. The gutters were installed using the older-style gutter spikes (long nails driven through the upper lip of the gutter) and ferrules (i.e., spacer tubes), as indicated in the previous photo by the red arrow, rather than the preferred method of using concealed hangers. Concealed hangers use screws to attach the gutters and are less likely to pull loose. Gutter spikes will often pull out over time unless they

penetrate the ends of the rafters. Reattachment can best be accomplished with the use of concealed hangers, one of which is indicated by the yellow arrow in the previous photo. The guttering should have a long life, but the sealant at the gutter joints will sometimes fail. When sealant failure occurs, causing leaking at a joint, the old sealant should be removed and new sealant applied.

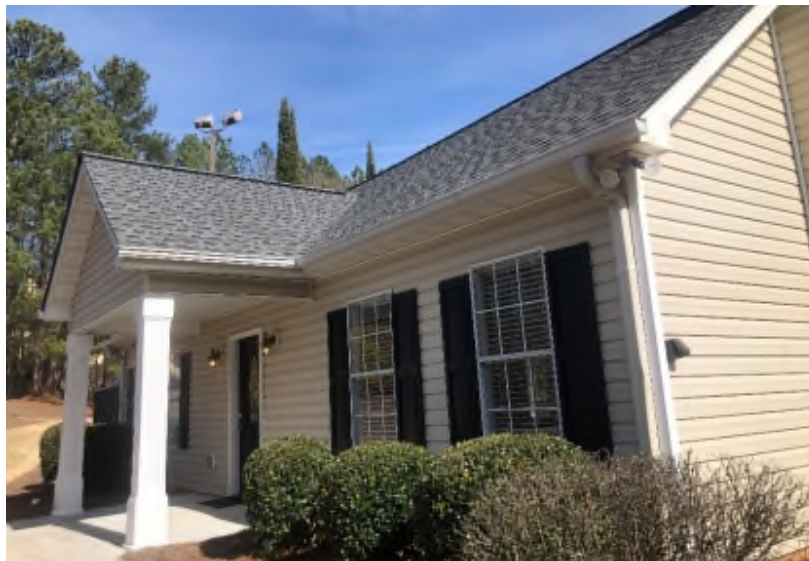
Exterior Rehab - 6-year normal life. Most of the exterior materials used for the clubhouse are prefinished and do not require painting: vinyl siding, guttering, vinyl shutters, vinyl soffit and trim, vinyl windows. This category includes washing the vinyl siding and painted surfaces, surface preparation, caulking and painting of all previously painted areas of the clubhouse. This category also includes funding to paint the interior of the pool restrooms because they get more use than the interior of the clubhouse. The paint in the restrooms is currently in good condition.

The surfaces that require painting are the exterior doors, the door jambs, the wood front columns, vinyl shutters, the aluminum rear columns (including the wood posts at the pool fence), and the chimney pan and flue. The paint on the door jambs at the storage room is failing (seen in the photo on the left), and the door jamb is deteriorating at the bottom. The paint on the precast aluminum base for the rear column seen in right photo is failing.

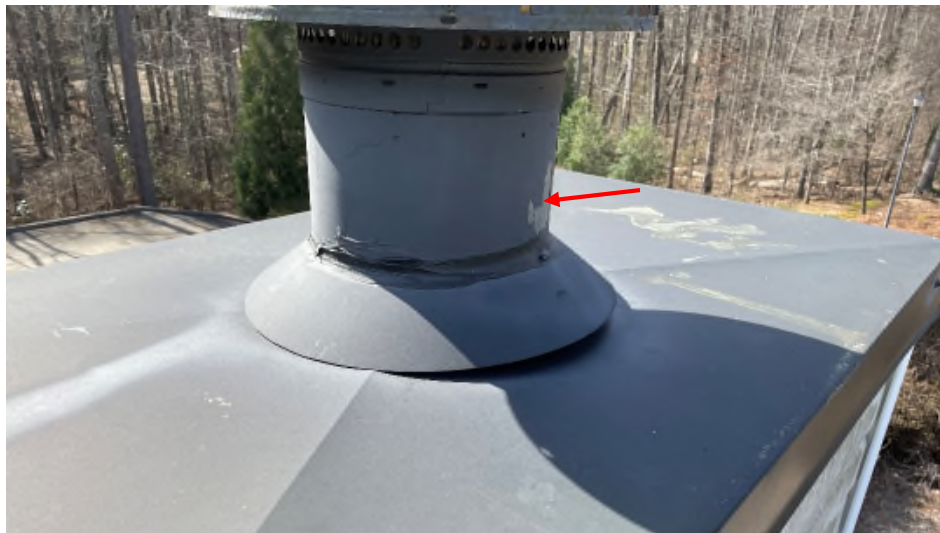
The chimney at the clubhouse has a sheet metal chimney pan at the top that acts as its roof. The top of the pan (see next photo) is formed so that water does not pond and it is painted which extends its life almost indefinitely. The chimney pan at Westminister Village is in good condition, but some of the paint is peeling off the flue as indicated by the red arrow. The eventual replacement of the pan would be funded by the **Infrastructure** category.

The replacement of the sheet metal chimney pan and shroud at the clubhouse chimney are covered by this category. The chimney pan at the Westminster Village clubhouse is currently in good condition.

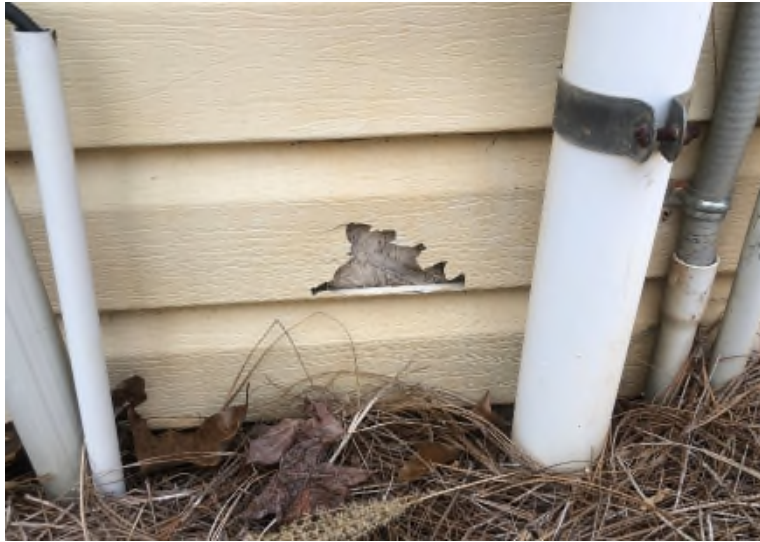
The vinyl siding is still in good condition. As vinyl siding ages, it will exhibit chalking. Chalking is a normal occurrence, and it is caused by oxidation. If a white substance comes off on your hand when you wipe the surface, that is chalking. Washing of the vinyl siding is included in the costs below as part of the **Exterior Rehab** project. This will help remove any chalking on the surface

of the siding, as well as mildew, algae, and other environmental contaminants. Over time, you will find that the sides of the buildings that receive the greatest amounts of direct sun will fade. The vinyl siding does not require painting, but it can be painted, and painting may help to extend the life of the siding (see the **Vinyl Siding** category also). Replacement of single pieces of damaged siding would be covered by this category. This is not an obvious area and replacement would be difficult, so a small piece could be applied as a patch.

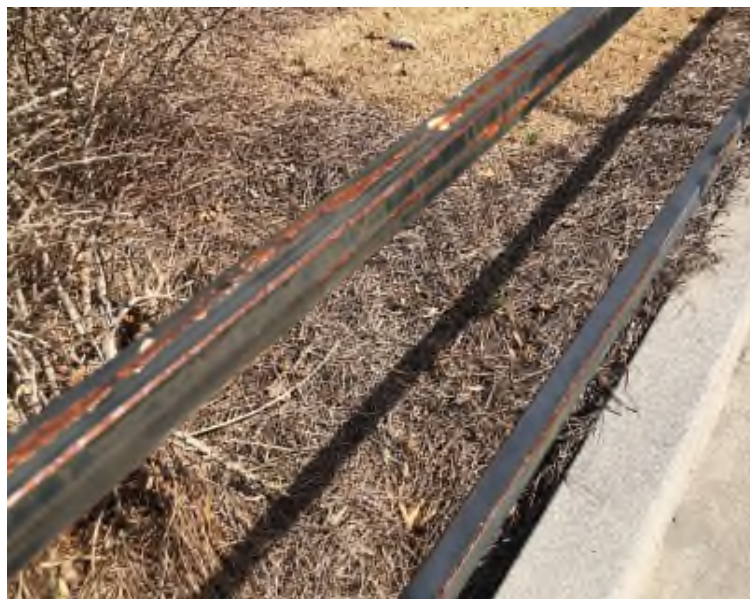
This category also covers the painting of the painted wood fencing at the property entrance, the tennis court light poles, and the metal handrails at the clubhouse. In the next photo, you can see that the paint is failing at some of the railings and rust has developed. These are welded steel railings and they can be repaired, if needed, rather than replaced. Proper prep work will be required before painting is done.

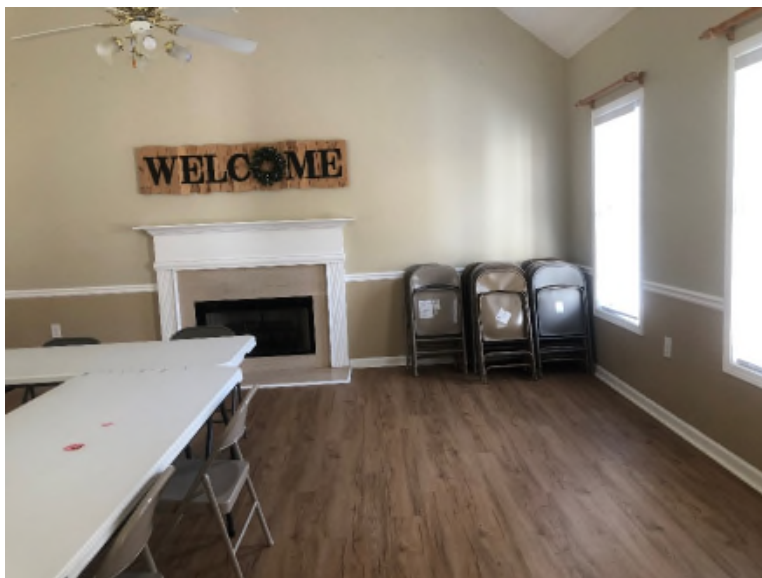
Clubhouse Interior Rehab -15-year normal life. The clubhouse has an indefinite life and the roofing, gutters and exterior painting are covered in other categories. This category provides a fund to replace the flooring, repaint the interior (excluding the restrooms, which are included in the **Exterior Rehab** category), replace the tables and chairs, replace the light fixtures and battery backed-up emergency/exit lights, replacement of HVAC components and renovate other miscellaneous items. It is understood that work is needed on the HVAC system, and a cost for that work is included in 2024 in the attached tables.

The clubhouse has a medium-sized interior area. There is laminate flooring in the main area and tile in the hallway and restrooms. The flooring and interior paint are in good condition. The tables and chairs are utilitarian and seem to receive light use.

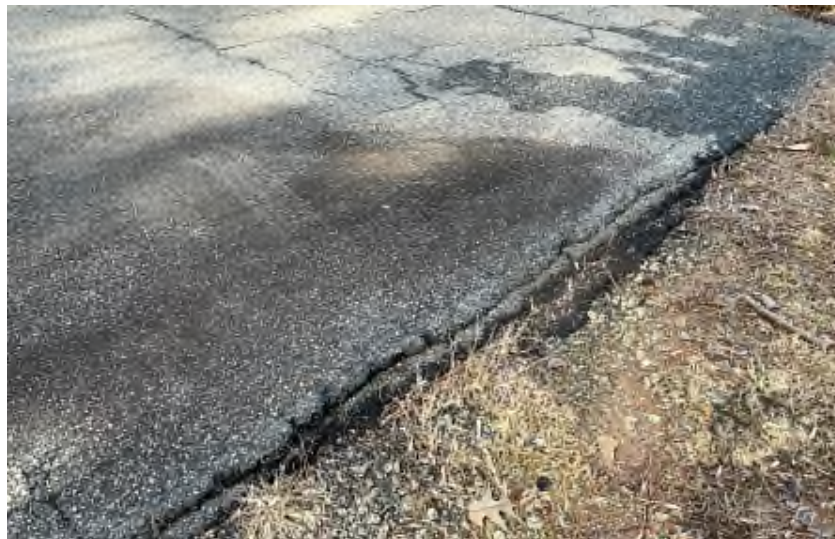
Asphalt Pavement - 28-year normal life. This category and the next provide funding for the asphalt at the property that is the Association's responsibility. It is understood that the streets are dedicated to the County so there is no provision for their repair, but this category and the next category cover the asphalt in the parking lot at the amenity area. This category covers the complete repaving of the parking lot with the exception of the concrete portion of the parking area, which is covered by the **Masonry** category.

The standard construction of asphalt pavement is compacted soil with four to six inches of well compacted base (i.e., crushed granite) and then asphalt layers totaling three to four inches. The durability of asphalt is determined at least as much by the strength and stability of the soil and base as it is by the quality of the asphalt pavement. The asphalt is in fair condition.

When the parking lot is re-paved, the technique used is generally to overlay the pavement with two additional inches of asphalt, but some Associations will have a one-inch layer applied. This looks good for a short time but then cracks appear in the same locations as the existing cracks. This is called reflective cracking.

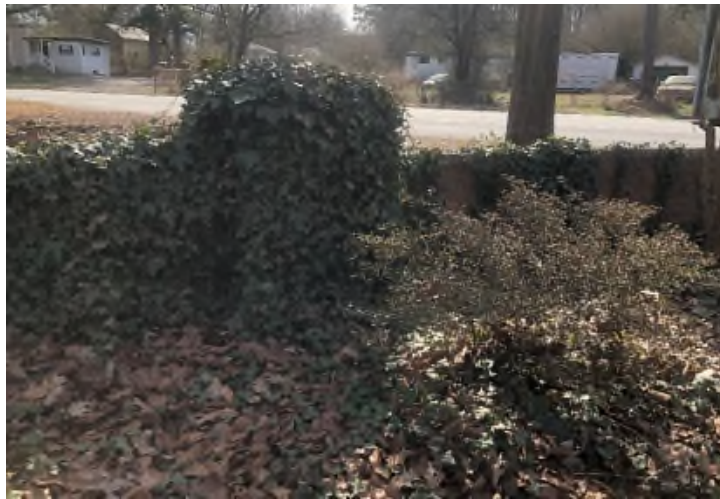
There is a large amount of ivy growing at the right side of the entrance (see the next photo). Removal of the ivy would be a normal maintenance activity, but a project to eliminate the ivy around the brickwork and install different plant material would be a project under this category.

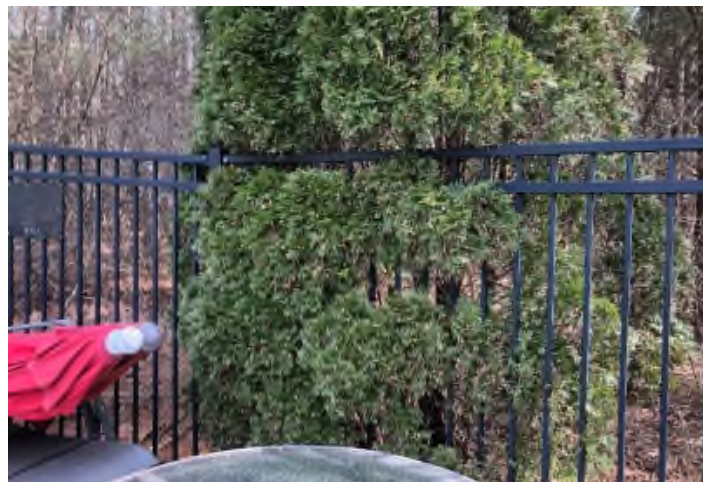
When plant material is installed, consider the eventual size. One of the evergreen trees outside the pool fence has grown through the fencing. Spacing between plants is also important.

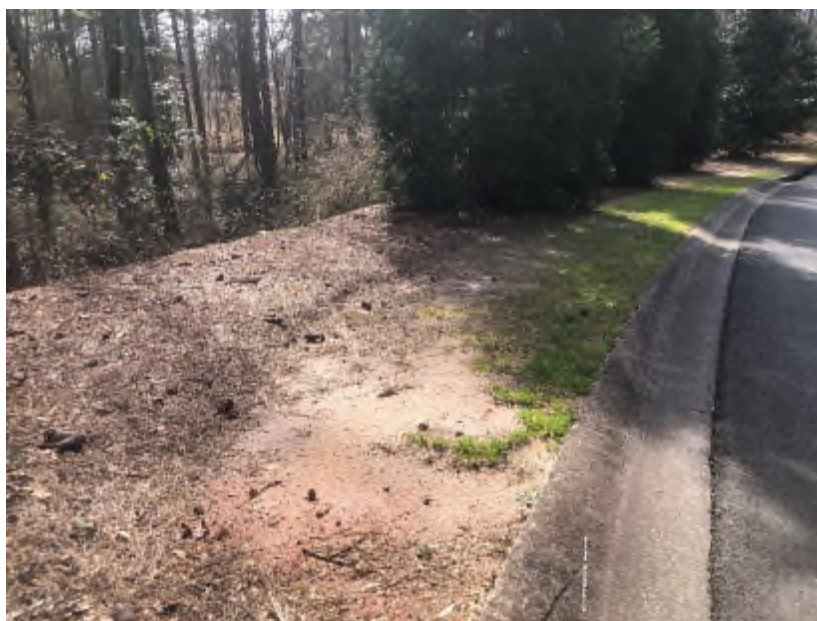
This category funds repairs to the surface drainage and erosion issues in the common areas. These issues tend to develop problems over time as water flow is altered by nature (i.e., plant material declining or dying) or by people changing something that then directs water in a different path. The sooner such problems are addressed, the less costly they will be. While the grass on the south-facing (exit) side of Westminster Village Boulevard gets sufficient sunlight, the north facing side gets only sparse sunlight, insufficient for the strip of grass. This area by the entrance road in the next photo below is being eroded by water flow coming off the hill. There are specific varieties of grass that perform better in shady conditions or there are other types of ground cover.

This same condition also exists at the area beyond the far end of the parking lot. As the trees in the natural area continue to grow, the shade will increase.

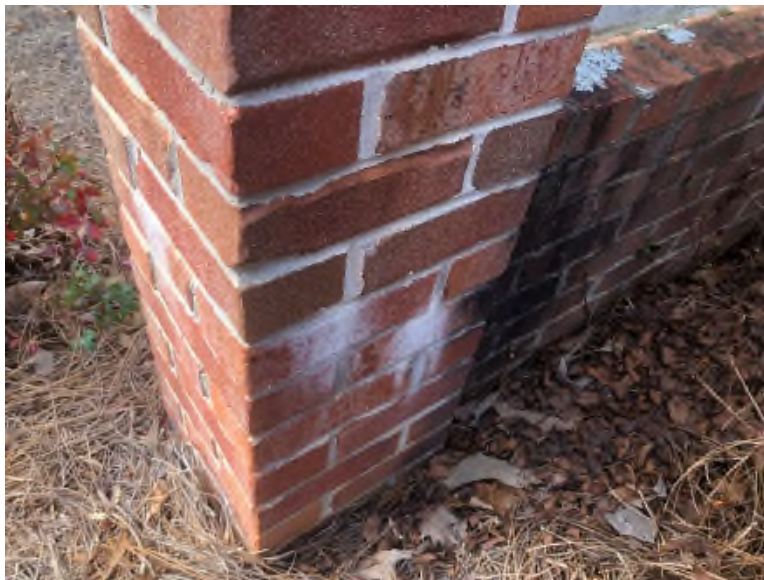
One issue to look for is the presence of efflorescence and liming. Liming is caused by water penetrating and dissolving calcium that is then deposited on the surface of the brick as a hard crust, and it can look similar to another condition, efflorescence. Efflorescence is the buildup of salts on the surface caused by moisture intrusion, generally from the top surfaces of the structure. Water penetrates, dissolves salts that are then deposited on the surface as the water evaporates, creating a cosmetic issue of white dust. Efflorescence can be removed by brushing it off the masonry, but it will come back unless the water penetration is prevented. Liming will become worse if not addressed, and it can be difficult to remove without an acid-based masonry cleaner.

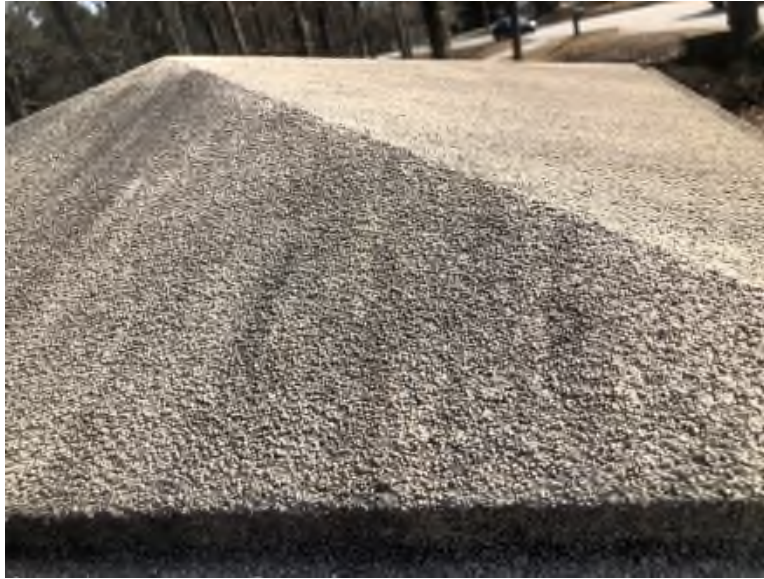
Also included is work on the EIFS details at the property. EIFS (i.e., “exterior finish and insulation system” synthetic stucco) is not actually masonry, but masons are typically the contractors who work with it. There caps of the brick signage monuments are made of EIFS (see the next photo). The EIFS should be cleaned and painted at each **Exterior Rehab** project. Repairs to the EIFS would be covered by this category.

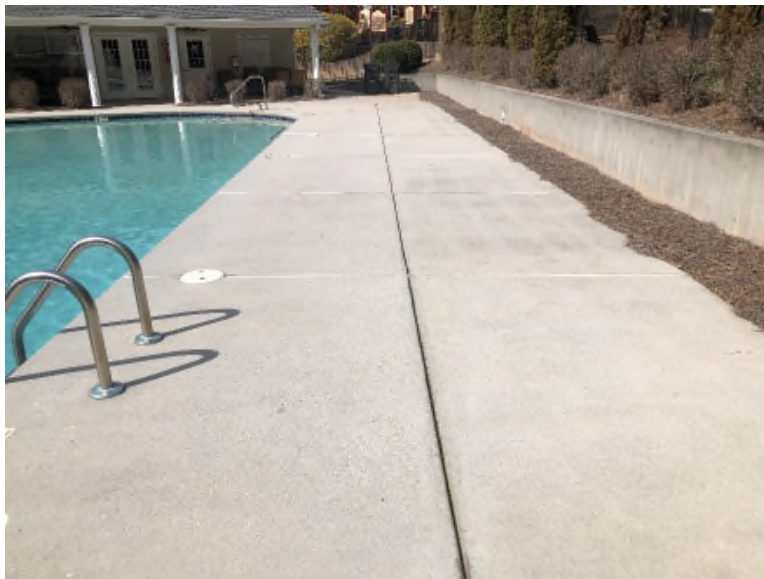
The largest single item in this category is the replacement of the pool deck at a cost of about \$40,000. Pool decks generally have a life of thirty to forty years depending on the quality of the original concrete and the workmanship. Replacing the pool deck is usually done when the pool is being re-plastered because the demolition of the pool deck sends a lot of debris into the pool. The pool deck is in good condition and it is unlikely that it will be replaced in this twenty-year period.

Some Associations will have a surface coating applied, but that is often not cost efficient because the coating is expensive (about 40% of the cost of a new pool deck), entails some additional maintenance expenses, and can flake off if it does not bond properly. Also, as problems develop in the original deck (such as cracking), that causes issues in the coating.

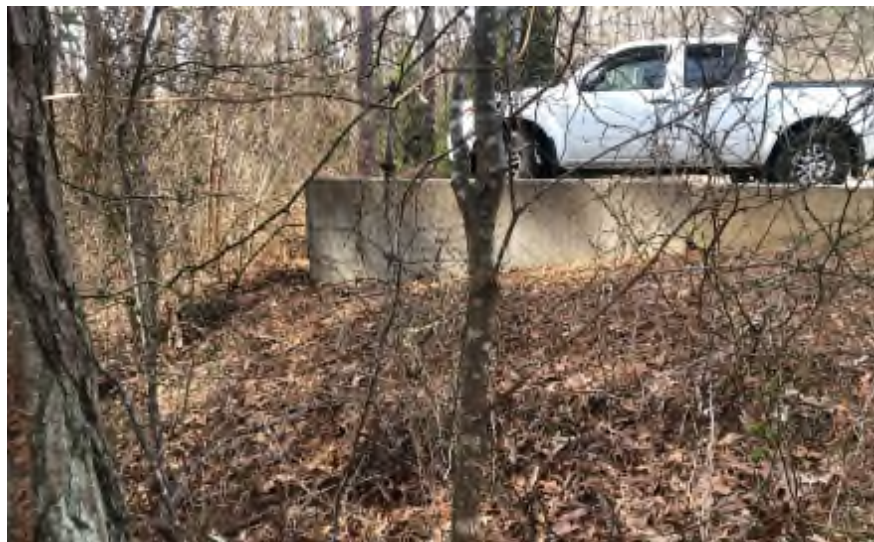
This category also deals with structural issues, which can include issues with the foundation of the clubhouse. It can also include issues at the amenity area and entrance that are the result of settlement. There are concrete retaining walls at the pool parking lot and between the pool and the tennis court. Repairs to these walls due to issues with the concrete would be covered by the **Masonry** category. Repairs to these walls due to structural or settlement issues would be covered by this category.

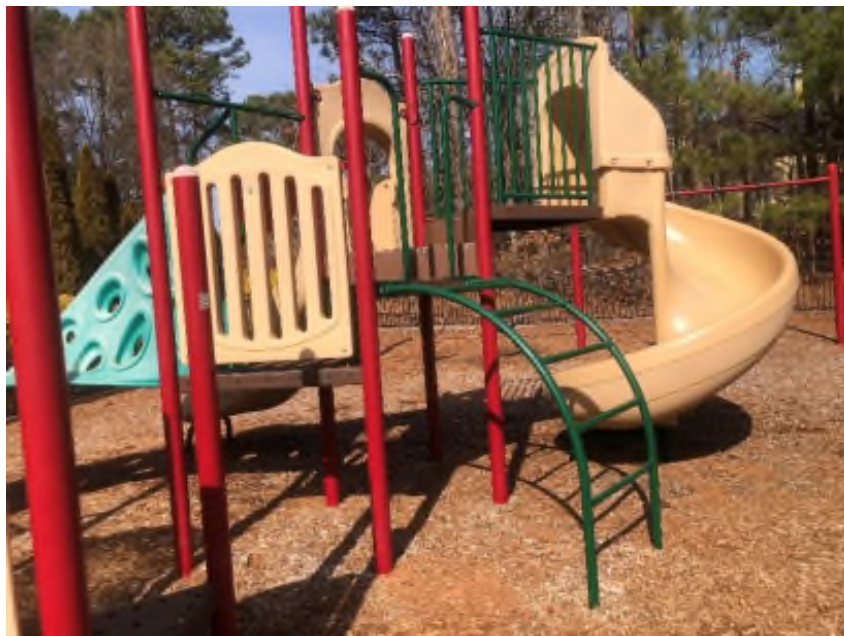
Playground Equipment - 25-year normal life. The playground equipment is located in the area beside the pool and clubhouse. The play center is a metal and plastic structure. It was installed around 2006 and is still in good condition. You may want to consider pressure washing it during each **Exterior Rehab** project. There is also a swing set and one bench that are in good condition.

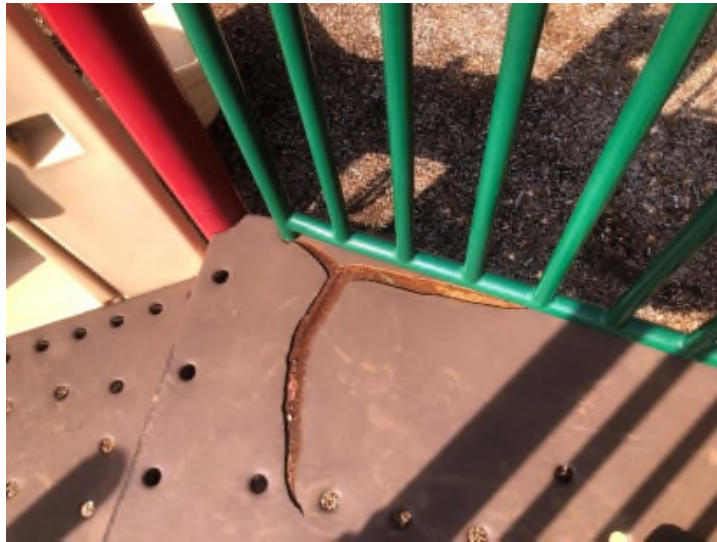
Some of the rubberized coating is torn, leaving the steel underneath exposed (see the next photo). The steel is rusting in this area.

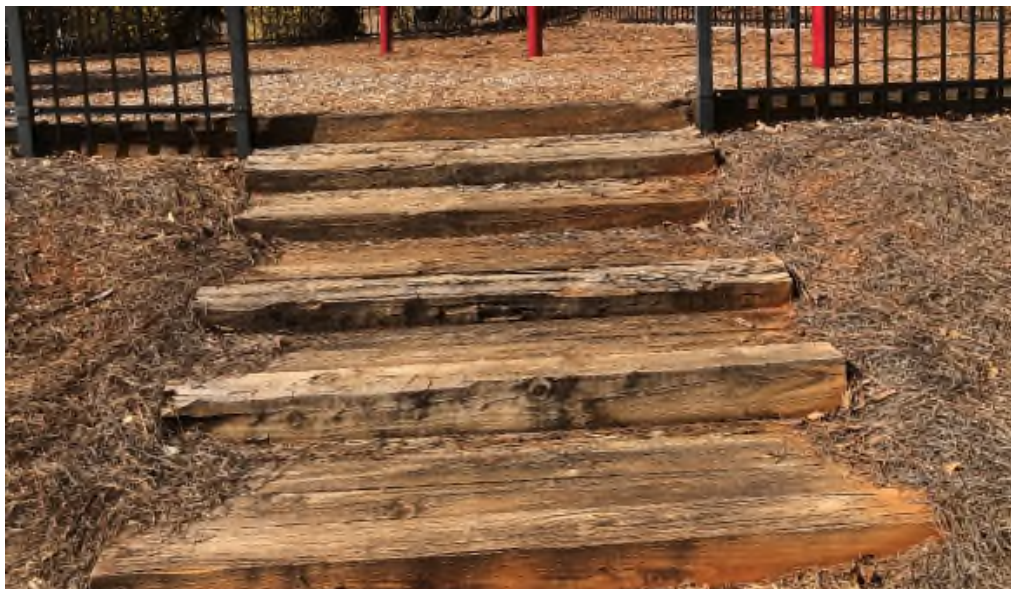
Wood timbers were installed for steps to the area and at the base of the fencing to help keep contain the mulch. The wood timbers are deteriorating and will need to be replaced soon, especially the steps. Alternatives to wood timbers are concrete for the stairs and plastic border sections for the perimeter of the area, both of which would have longer lives.

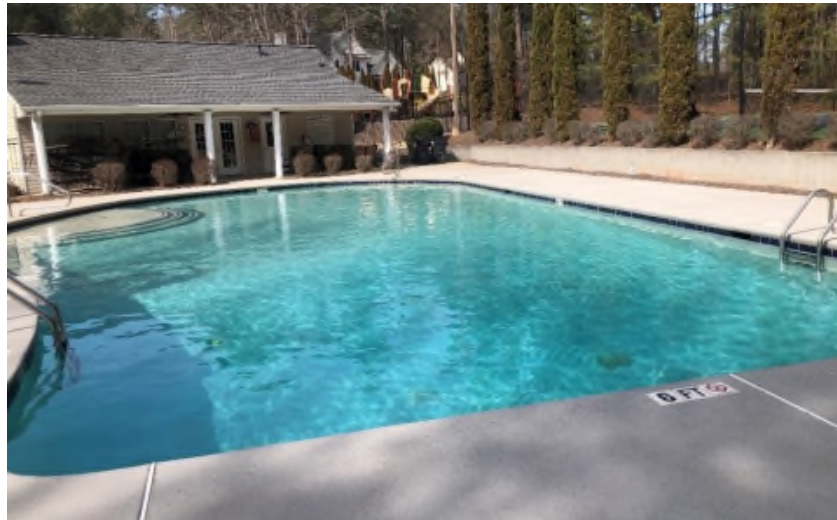
Pool Surface - 18-year normal life. Over about eighteen years the plaster surface of the pool erodes to the point where it is rough and pitted. The pits in the surface are ideal habitat for various types of algae. When the surface becomes rough, the pool needs to be replastered. The plaster surface for Westminister pool was plastered prior to the 2022 pool season and is in very good condition.

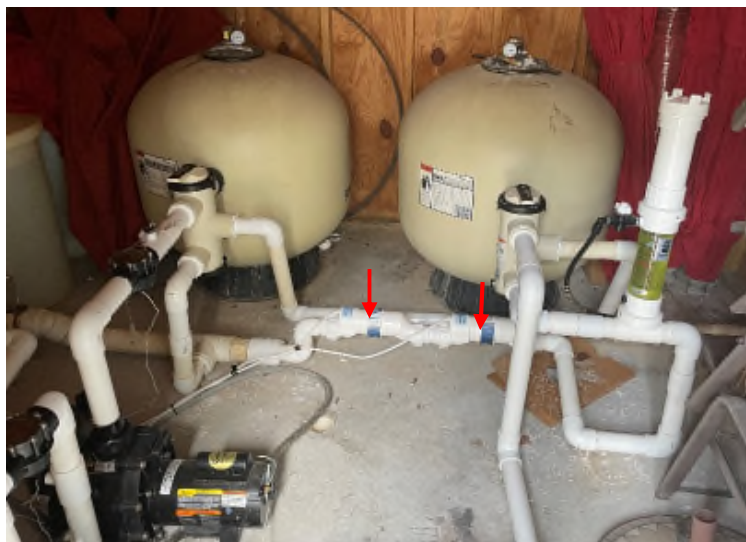
Pool Equipment - 8-year normal life. Includes replacement of the pool pumps and motors, two sand filters, and the chlorination equipment. Also included in this category is an allowance for work on the piping of the re-circulating system and some electrical wiring. In speaking with Swanson Pool Solutions, the equipment is in good condition.

The pumps and motors are single speed equipment. Health Departments in metro Atlanta, but not yet in Coweta County, are being pressured by the federal government to promote energy efficiency for community pools. Single speed motors are no longer being manufactured but will still be available for a while. Eventually, the single-speed pumps and motors will need to be changed over to a variable-speed motors as an energy conserving measure. This will also require the replacement of the pumps. That equipment is about twice as expensive as the present equipment but is likely to pay for itself during its lifetime in lower energy costs.

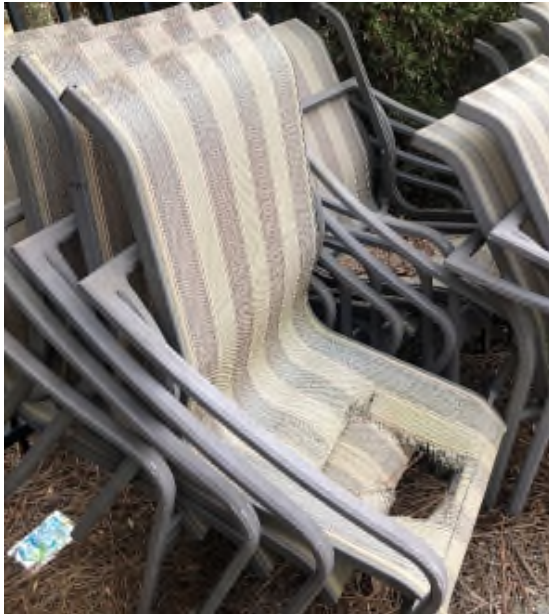
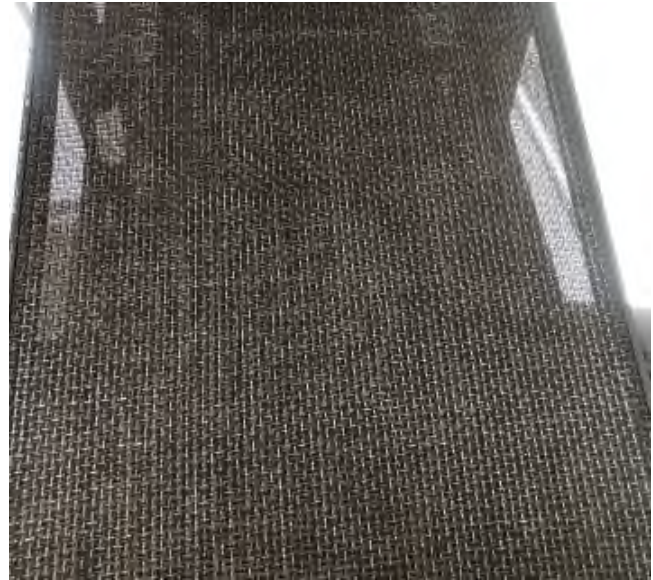
of older, mostly damaged slingback chairs (see the photo on the left) and newer slingback chairs in good condition. The Association has included the replacement of the pool furniture in the 2023 budget.

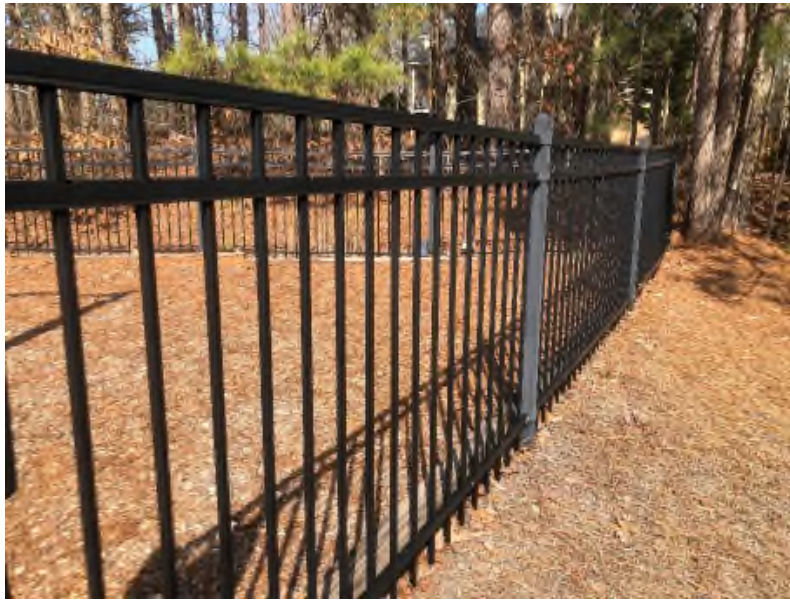
The fencing has not been painted, and it is fading, particularly the fence posts at the pool. If painting is desired, it would be added to the **Exterior Rehab** category.

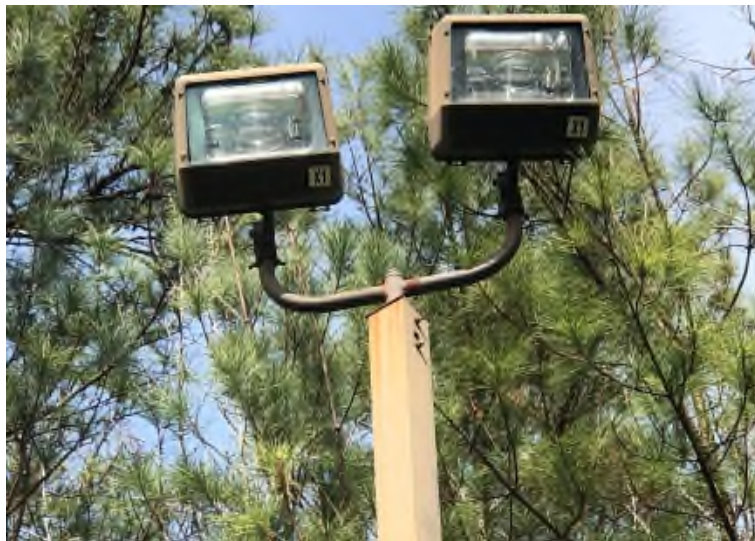
Tennis Court Lights – 35-year normal life. There are eight 1000-watt halide lights on four poles at the tennis courts. The poles have an indefinite life. The painting of the poles would be covered by the **Exterior Rehab** category. The pole seen in the next photo has been discolored by rust developing on the arm of the light fixture.

The bulbs and parts of these lights will still be available for some time, but the industry is moving to a newer generation of LED tennis court lighting (see the next photo from another of our clients). The fixtures are twice as expensive as the lights you now have, but they are much less expensive to operate. If the courts are often used at night, the LED fixtures would be a cost savings in the long run. The costs below are for the LED light fixtures.

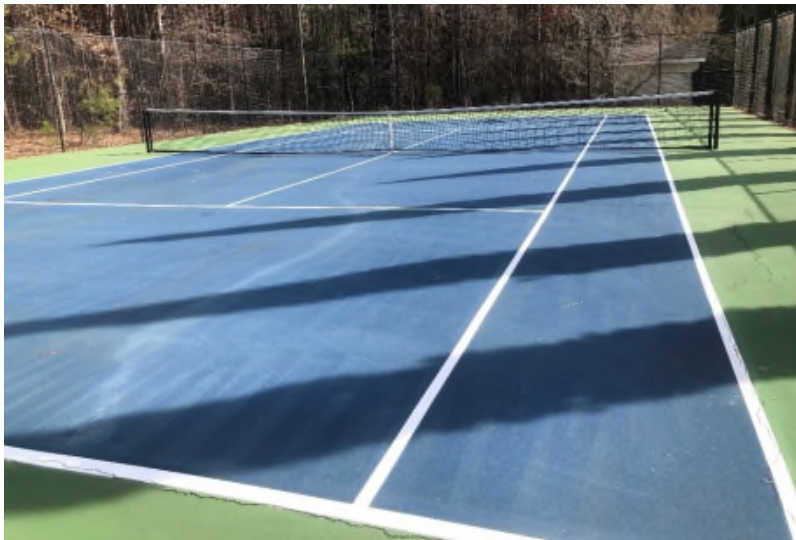
Tennis Court Surface - 5-year normal life. This category provides funding for the reapplication of the colored surface of the tennis court, the restriping of the court, and the replacement of the net.

The tennis court at Westminister Village is in fair condition, but there are many cracks. Cracks generally appear in tennis courts after 10 to 15 years in the joints between sections of the

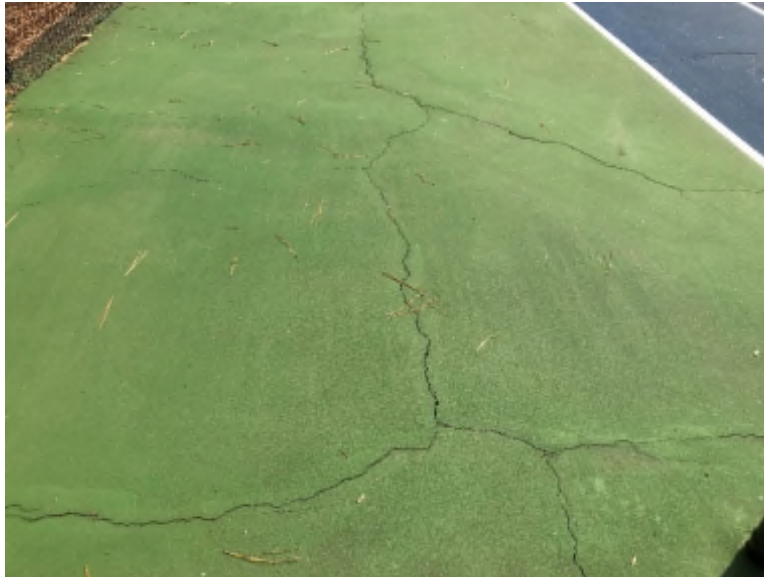
asphalt pavement. As seen in the next photo, there are cracks that are not at the joints, and some of the cracks are intersecting. The cracking will get worse.

The cracks are easy to repair if a short-term approach is acceptable. Basic crack repair during the application of the colored surface is only effective for about a year before the cracks begin to reappear. There are crack repair techniques that are guaranteed for five years, but the cost is high (between \$11 and \$15 per linear foot). The cost of this type of crack repair can be prohibitive if there are numerous cracks.

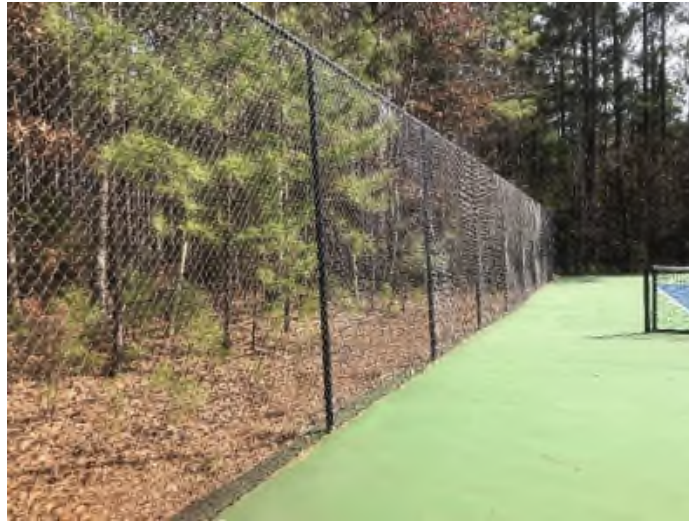
Tennis Court Fence – 35-year normal life. You have 349 linear feet (LF) of 10-foot tall, vinyl-coated chain-link fencing at the tennis court. This category funds the replacement of the fencing when it reaches the end of its life.

The poles should last indefinitely, but the fence fabric will need to be replaced. The existing fence is good quality, but at the tennis courts, there is only has a tension wire to hold the chain-link fabric at the bottom. This can be unsatisfactory where there is vigorous play (i.e., with people crashing into the fence). A horizontal pole at the bottom can sometimes help keep the fence from curling.

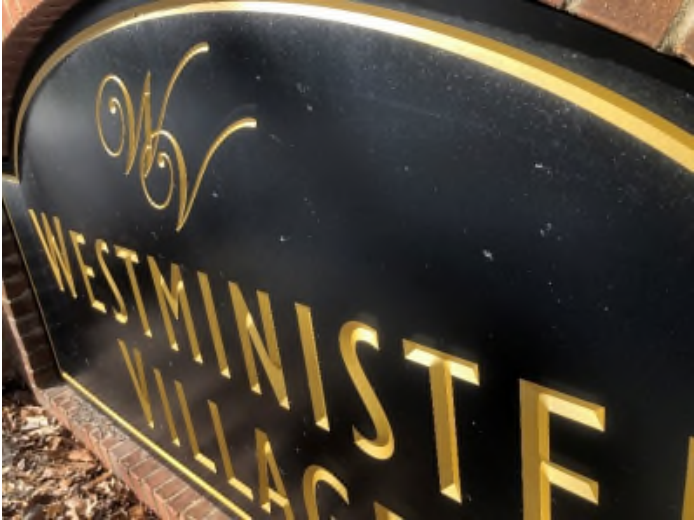
Signage - 20-year normal life. The main signage for Westminister Village consists of three large signs at the main entrance and one sign at the rear entrance. One sign is mounted to either side of a brick monument in the middle of the main entrance road. The third is mounted to a brick monument on the north side of the entrance. The signs are made of a routed acrylic material. The gold lettering will wear off but can be repainted. The main entrance signs are in good condition. The rear entrance sign is mounted to a brick monument. This category funds the refurbishment and replacement of the entrance signage. The brick monuments are covered by the **Masonry** category.

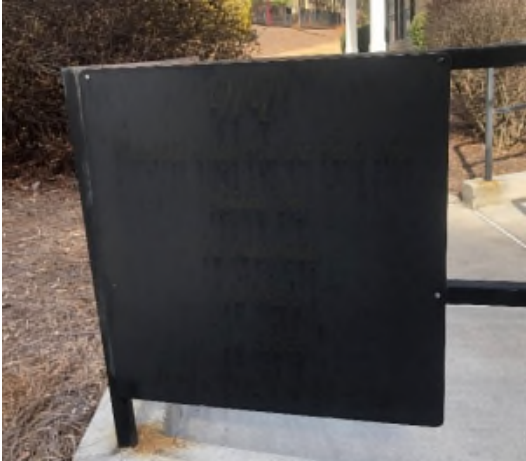
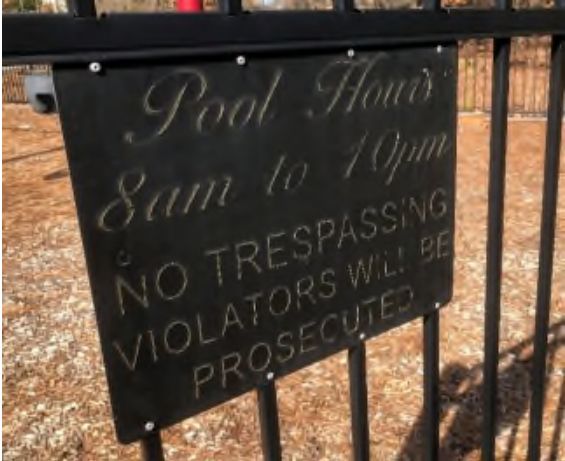
There is also some miscellaneous signage. There is a changeable sign in front of the clubhouse that is in fair condition, and there are metal signs at the amenity area that are in poor condition. A cost to replace these signs is included in 2023 in the attached tables.

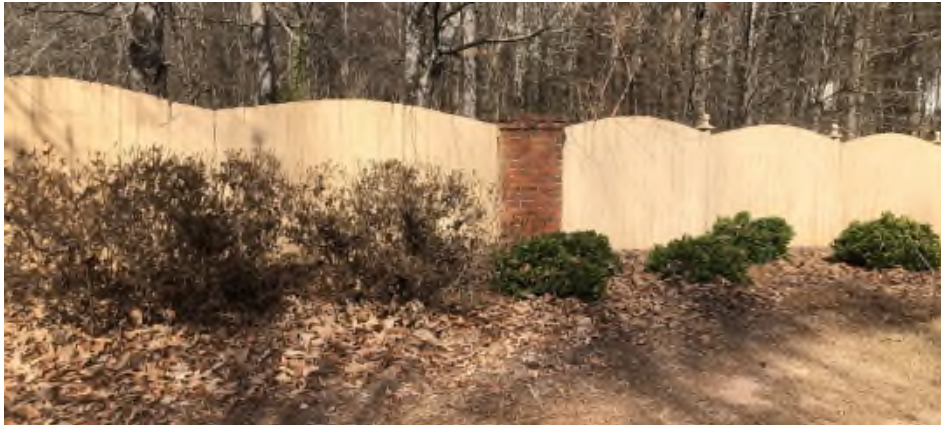
Wood Fencing – 24-year normal life. This category covers the replacement of the 337 linear feet (LF) of domed wood fencing along either side of the entrance road. The wood fencing is in fair to poor condition.

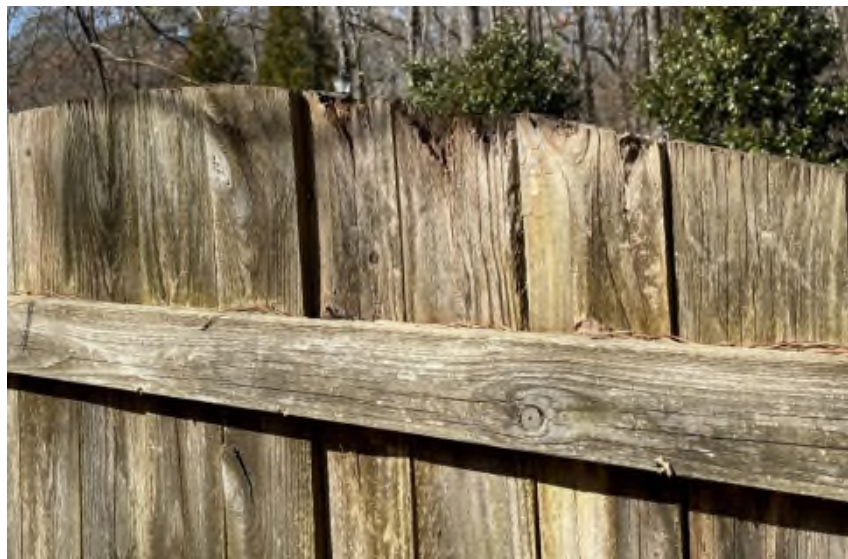
The fencing appears to be original with the property which would make it about twenty-five years old. Some of the pickets are warped and others are deterioration on the top edge as seen in the next photo.

Individual damaged pickets and sections can be replaced to extend the life of the fencing, but this category covers the total replacement of the fencing. The fencing has been stained, and the re-staining of the fence would be covered by the **Exterior Rehab** category.
